09/20/81 World Airways, Inc.

Official Accident Report Index Page

Report Number	NTSB-AAR-82-1
Access Number	PB82-910401
Report Title	Airways Inc., Flight 32, McDonnell Douglas DC-10-30CF, N112WA, Over North Atlantic Ocean, September 20, 1981.
Report Date	January 12, 1982
Organization Name	National Transportation Safety Board Bureau of Accident Investigation Washington, D.C. 20594
WUN	3378A
Sponsor Name	NATIONAL TRANSPORTATION SAFETY BOARD Washington, D. C. 20594
Report Type	Aviation Accident Report
Sup Notes	The subject report was distributed to NTSB mailing lists: 1A, 8A and 8B.
Distribution Status	This document is available to the public through the National Technical Information Service-Springfield, Virginia 22161 (Always refer to number listed-in item 2)
Report Class	UNCLASSIFIED
Pg Class	UNCLASSIFIED
Pages	54
Keywords	DC-10, galley lift system, design deficiencies, operations procedures.
Abstract	About 0245 G.m.t. on September 20, 1981, a flight attendant on board World Airways Flight 32, a DC-10-30CF, was fatally injured as a result of being trapped between a service cart in the galley personnel lift and the ceiling of the lower galley as the lift raised. There were 331 reve

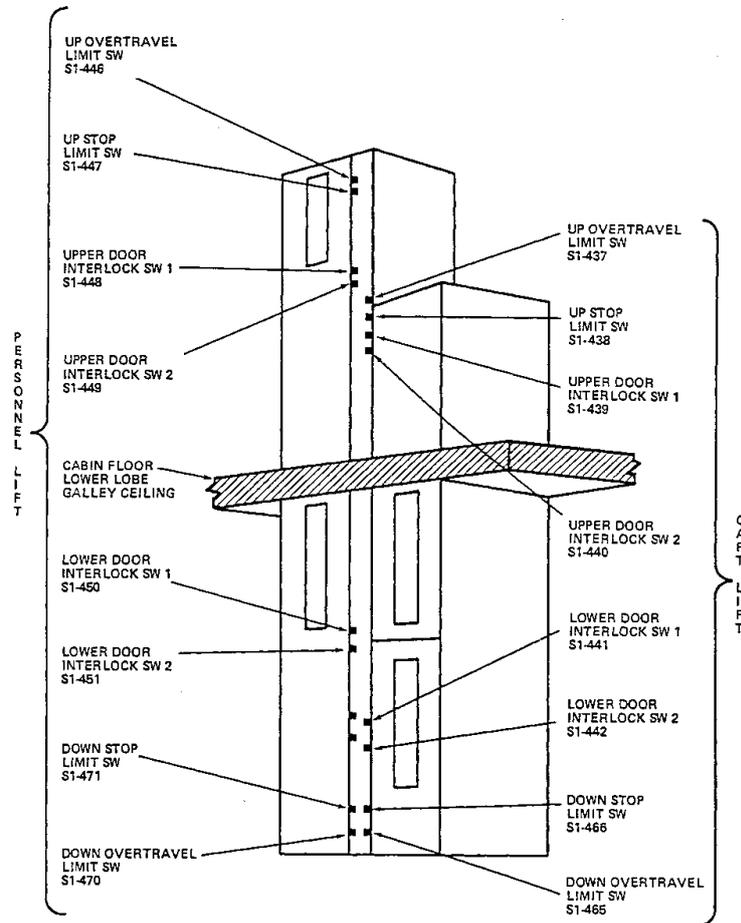
Figure 1.--Galley lift system with electrical switch locations.

Limit Switches - The range of travel of the lifts is controlled by limit switches installed within the wire duct attached to the forward side of one of the vertical lift tracks. There are two sets of two limit switches for each lift; one set located in the service center and one set in the lower galley. One switch is a normal stop switch and the other limit switch is for overtravel in the event the normal switch fails to operate. The limit switches are actuated by a cam plate mounted on the side of the lift. The cam plate has a machined offset to prevent actuation of the overtravel limit switch unless the normal switch fails to operate. In addition to the limit switches, mechanical stops are installed in the vertical lift tracks to stall and shut off the gear motors if both limit switches malfunction. (See figure 1.)
